3.3.9 Wash Brook Bank Erosion Repair

3.3.10 University of Hartford Dam Removal

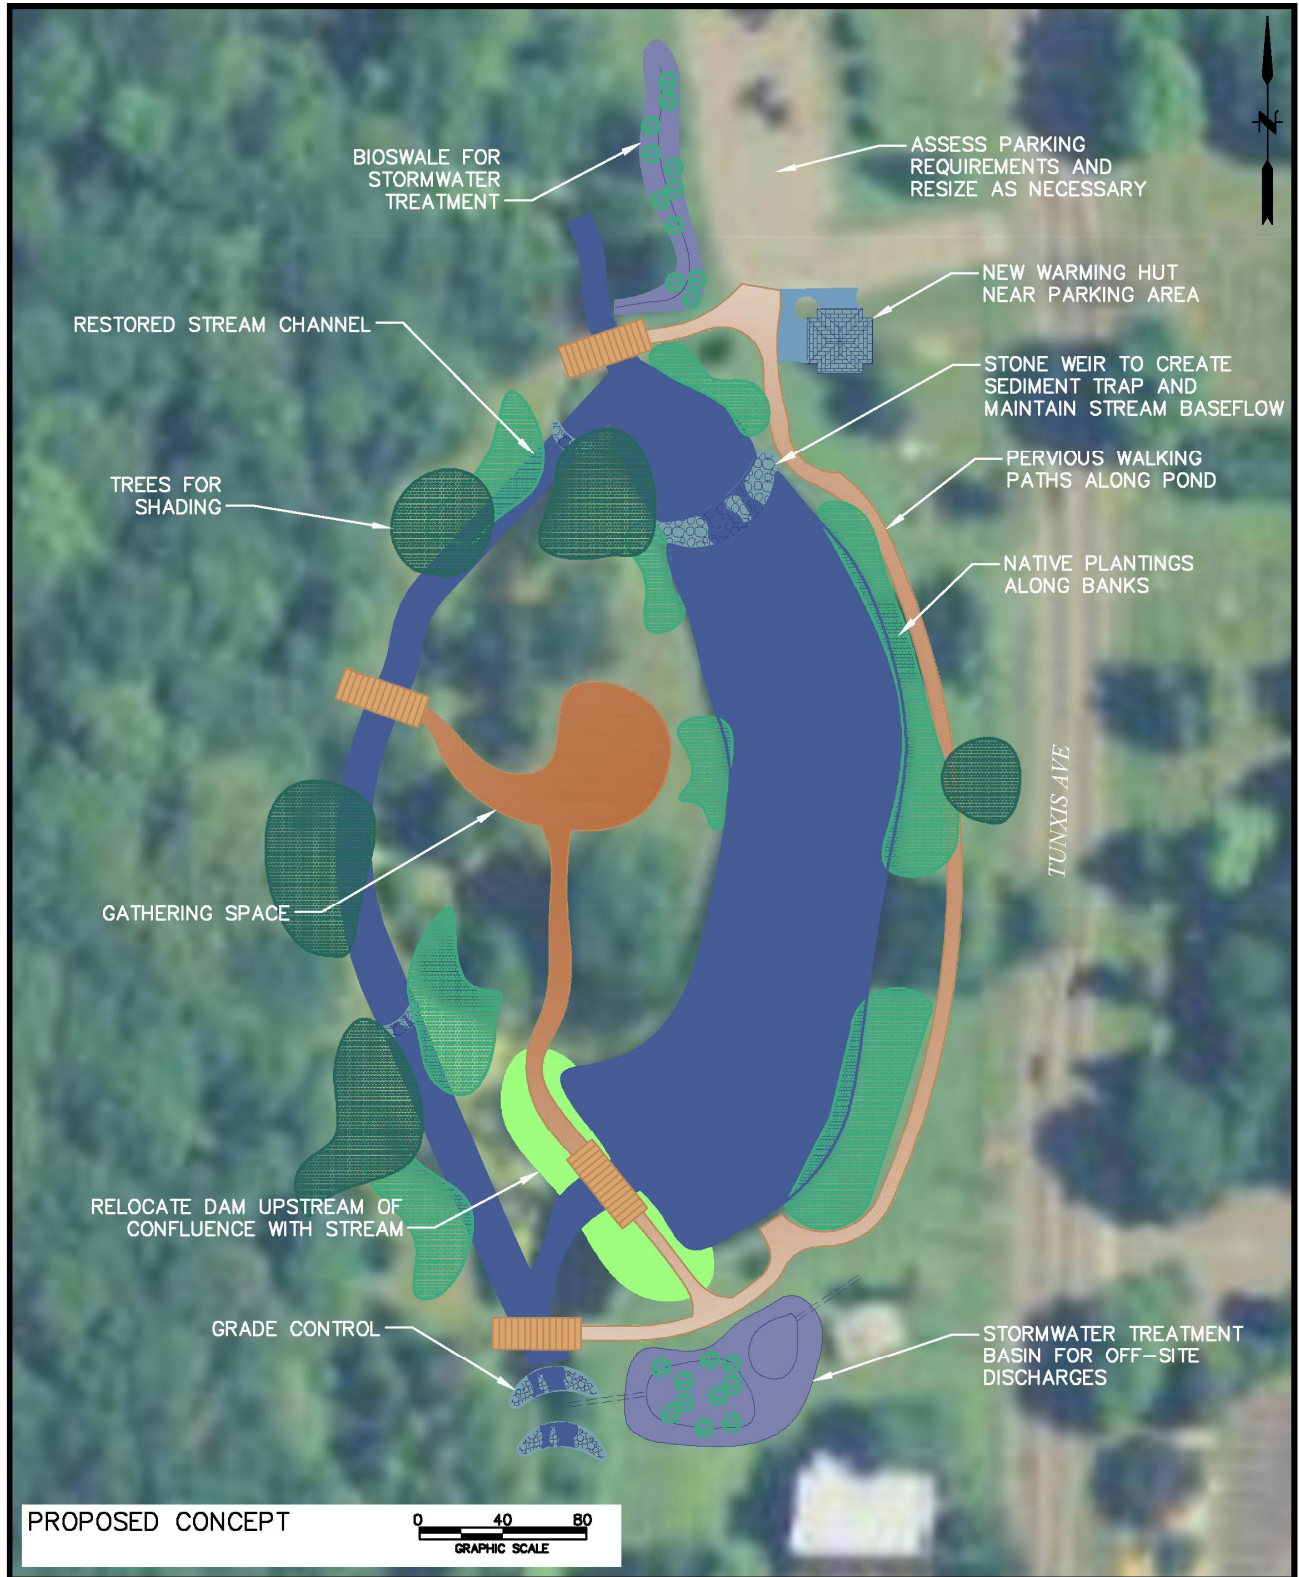
Figure 3-11b. Filley Park Pond Habitat Improvement Concept

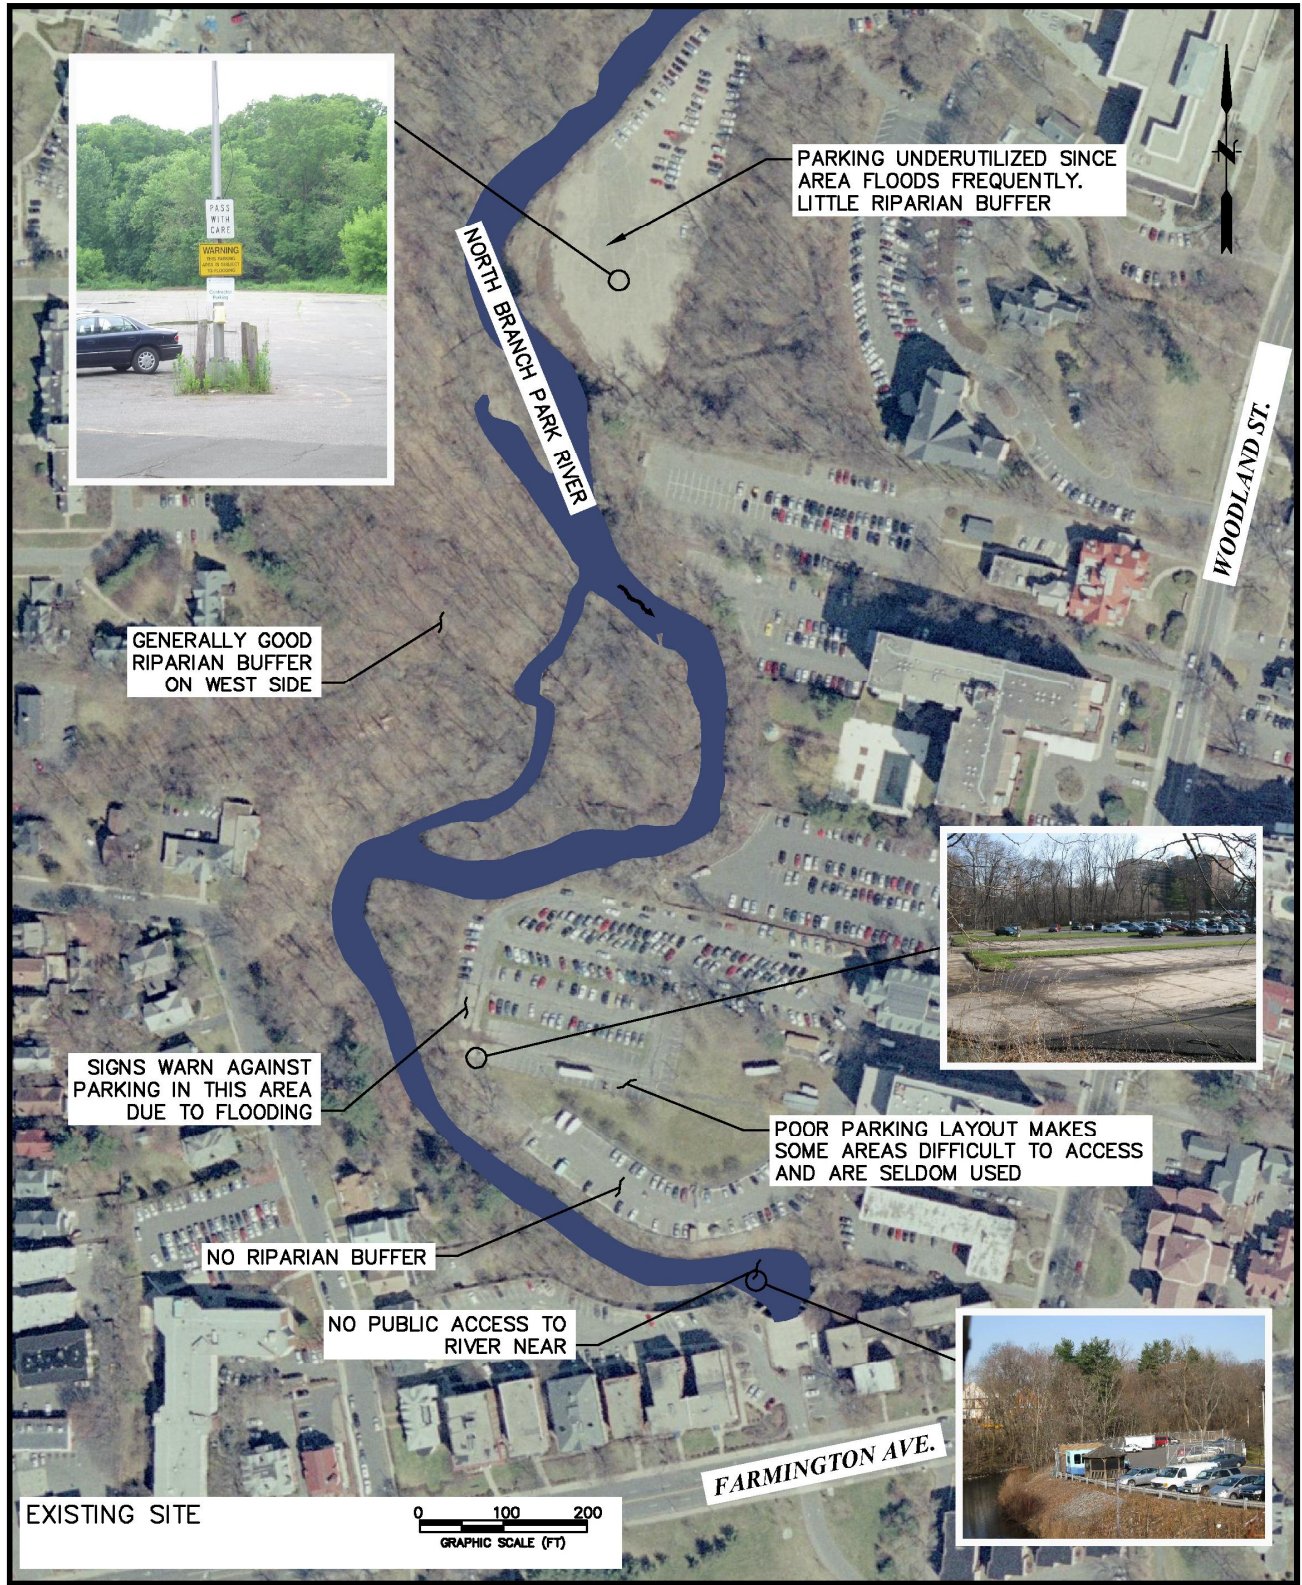
Figure 3-12a. Lower North Branch Park River – Existing Conditions

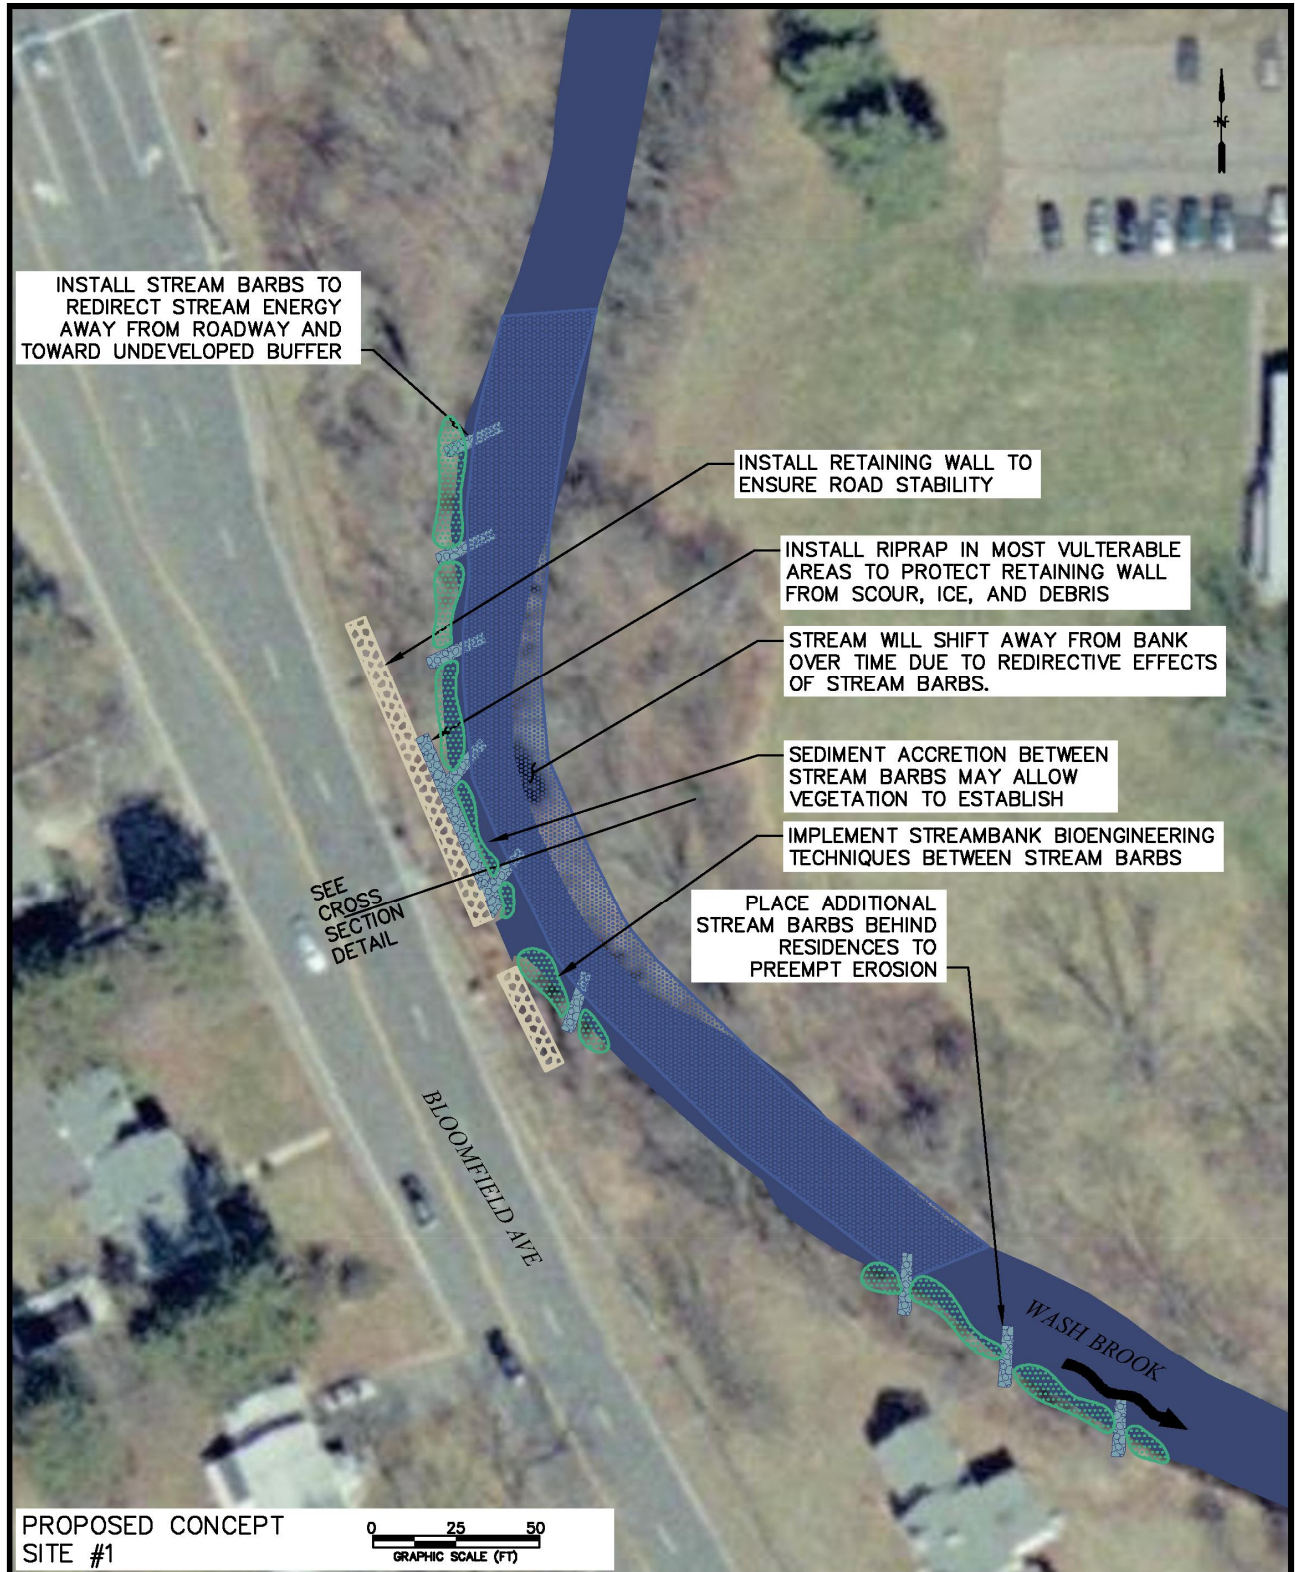
Figure 3-13b. Wash Brook Bank Erosion Site #1 Bank Stabilization Concept

Stream restoration techniques are proposed to address the ongoing bank erosion in these two areas. Potential restoration efforts to address the problem would require coordination between the Town of Bloomfield, the Connecticut Department of Transportation, and private property owners. The proposed stream restoration concepts (*Figure 3-13a through Figure 3-13d*) include the following elements:

- Implement stream restoration measures at the upstream location, which may include:
 - Redirective techniques, such as a transverse vane or stream barbs to direct stream energy away from the eroding bank (stream barbs are shown in the concept sketch). The purpose of the proposed redirective techniques is to transfer the stream energy at the outer bank of the river toward the center of the river or the opposite bank.

- Stabilize the roadway embankment. An engineered structure such as a retaining wall or gabion wall may be necessary since little area is available between the river and the edge of the roadway and because there will be very little tolerance for further migration of the stream channel following construction. The toe of the wall will also need to be protected against scour and ice damage. Additionally, these techniques should be extended beyond the eroded area, especially downstream, to avoid impacting the residences that abut the river.

- Increase the riparian buffer width on the opposite bank, since redirecting stream energy could cause stream migration in the opposite direction over time.

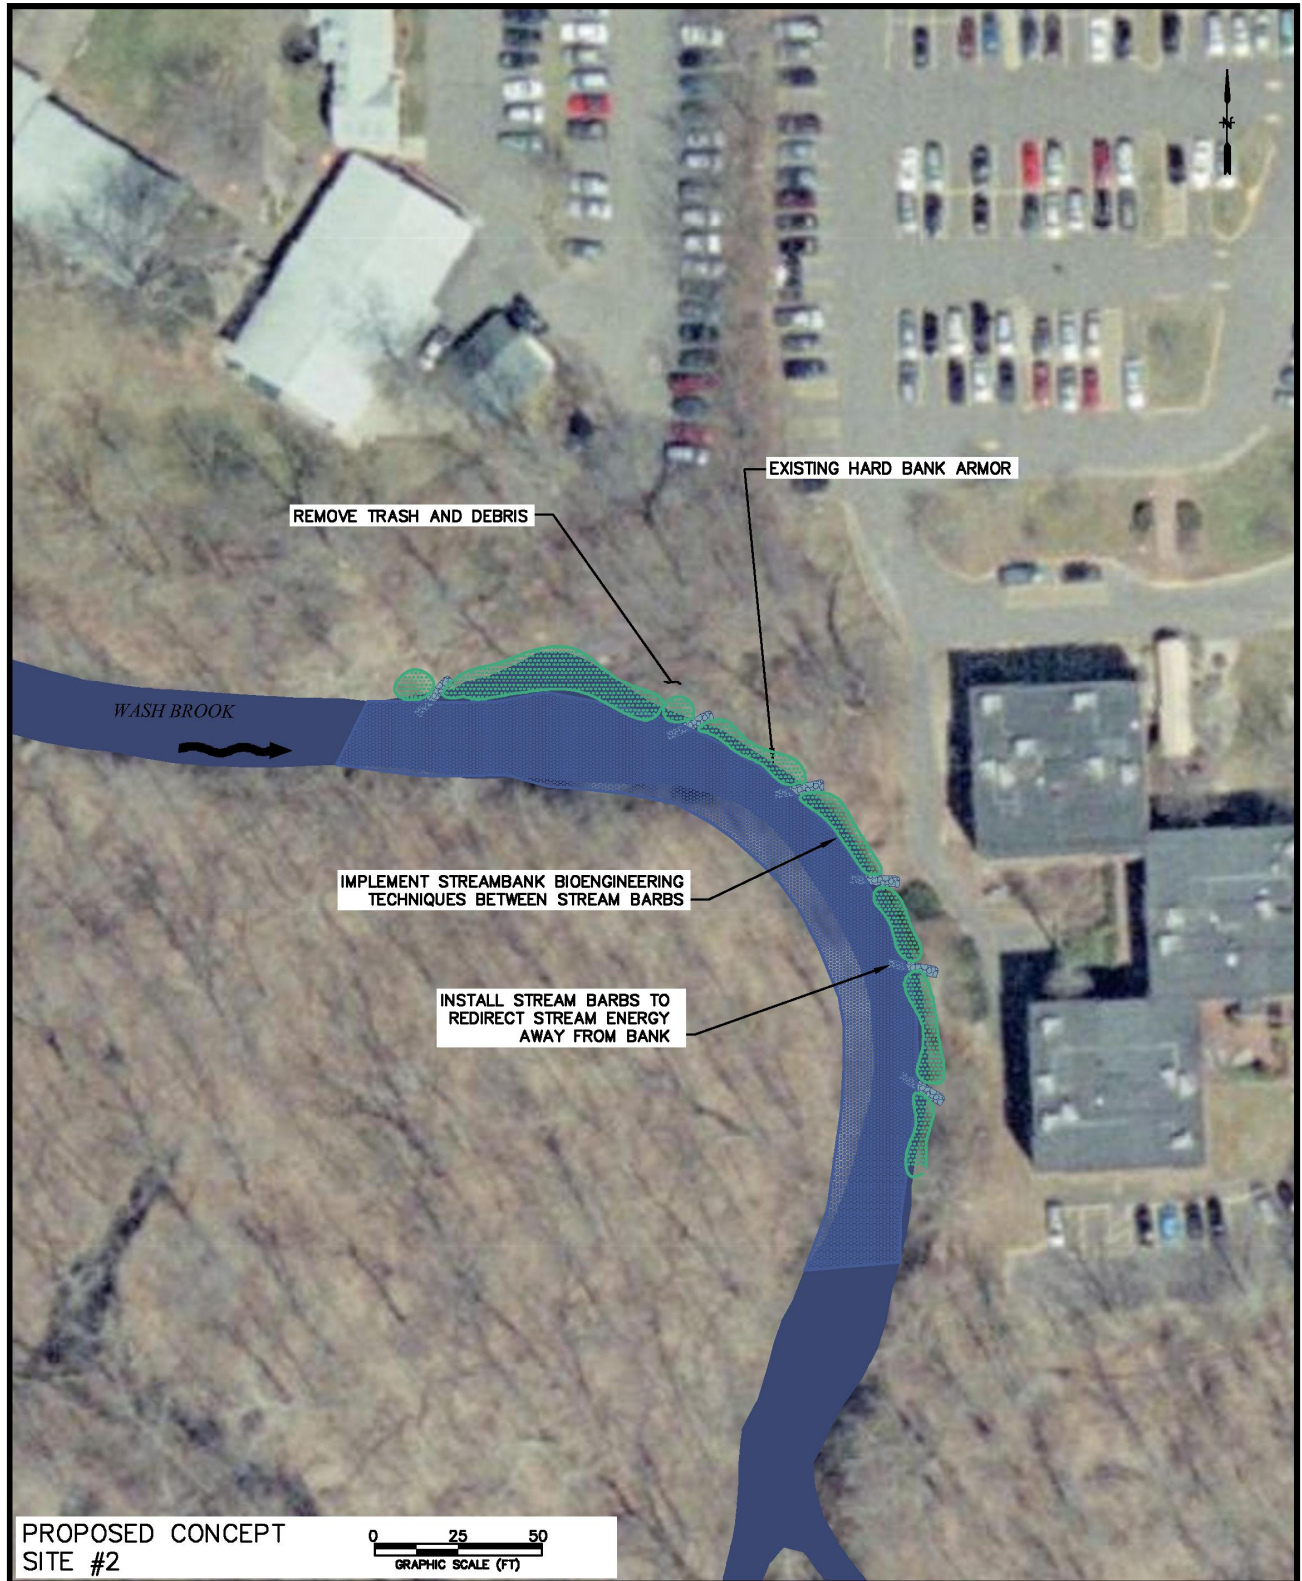
Figure 3-13d. Wash Brook Bank Erosion Site #2 Bank Stabilization Concept

- Downstream location:
 - Remove dumped landscaping debris and trash
 - Consider implementing redirective techniques when additional stabilization becomes necessary in the future

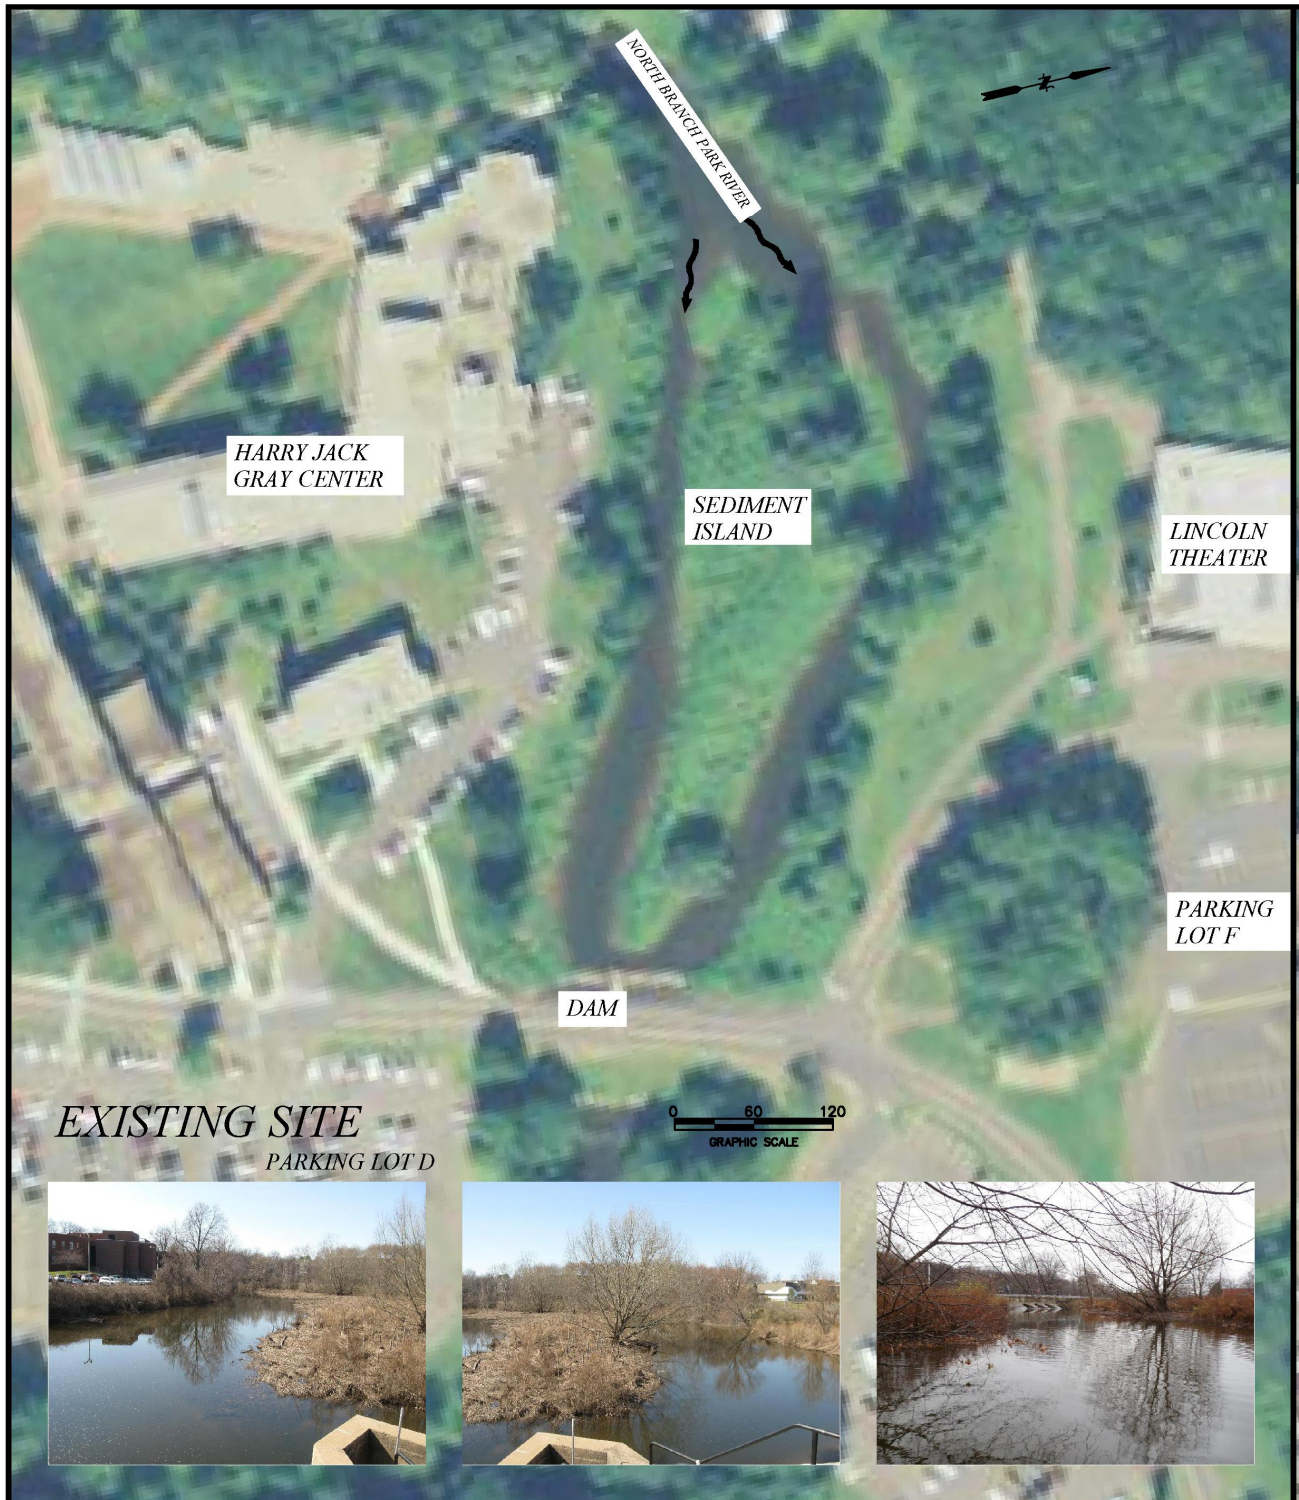
Figure 3-14a. University of Hartford Dam – Existing Conditions

A dam on the University of Hartford campus serves as the first obstruction upstream of the North Branch Park River conduit entrance. The dam is an earth embankment structure with a campus roadway along its crest. The river is conveyed through the dam via eight large corrugated metal pipes.

The pond today, has very little open water due to the accumulation of river sediment over the past half a century. The dam has reached its useful design life and is now beginning to fail. It was designed in the 1950s using a technology that was prevalent at the time. The main spillway and drain pipes through the dam are composed of corrugated metal pipe or CMP. CMPs have been observed to have a useful design life of approximately 50 years. They fail by corrosion of the metal and therefore loss of structural integrity. The piping in the dam is beginning to fail due to corrosion.
